Joe Hudson 9/7/2015 PML Differential Cover

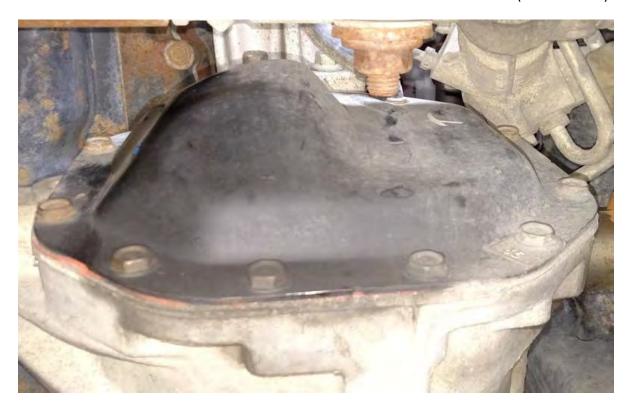
The stock cover's lower bolts were removed from the underside of the truck (bottom view).

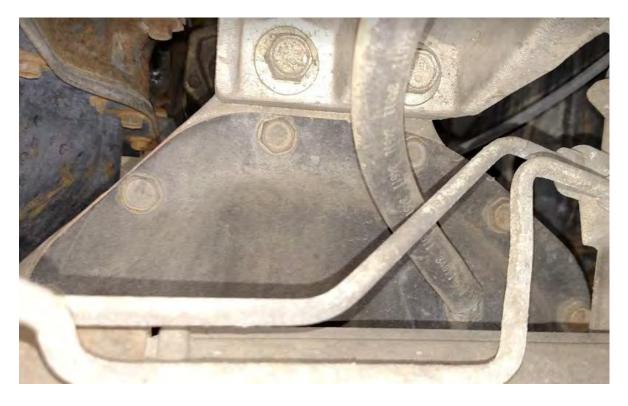
The upper bolts were accessed by removing the front splash shield (front view).

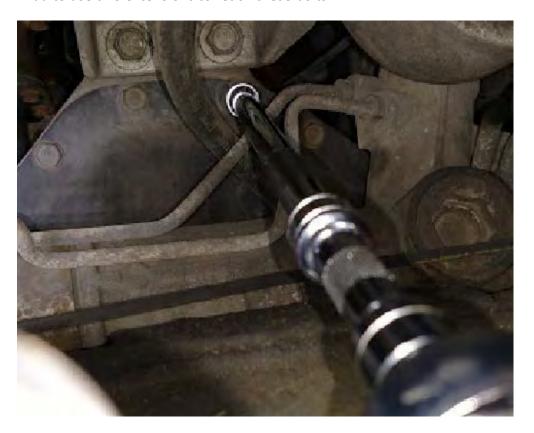
I had to use two extensions to reach these bolts.

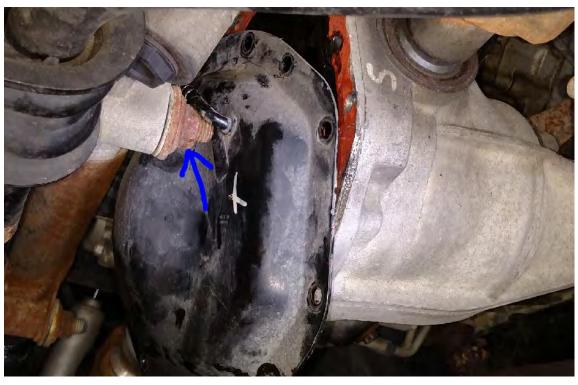
Removing the stock cover required the removal of the steering rack nut so the rack bolt could be pushed back.

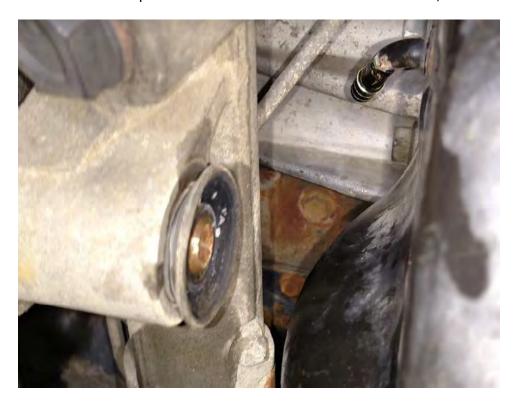
Once the bolt was pushed back and the vent tube hose removed, I was able to remove the stock cover.

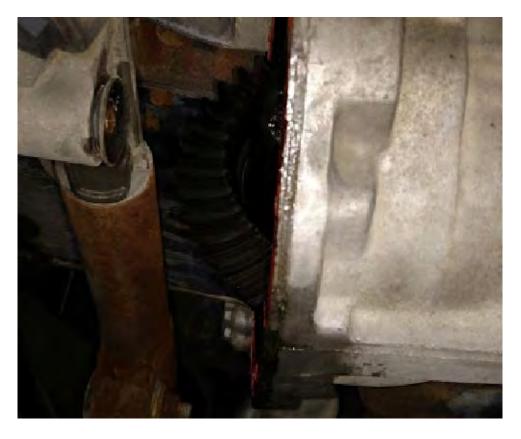
This picture shows how much the ring gear protrudes from the front differential housing.

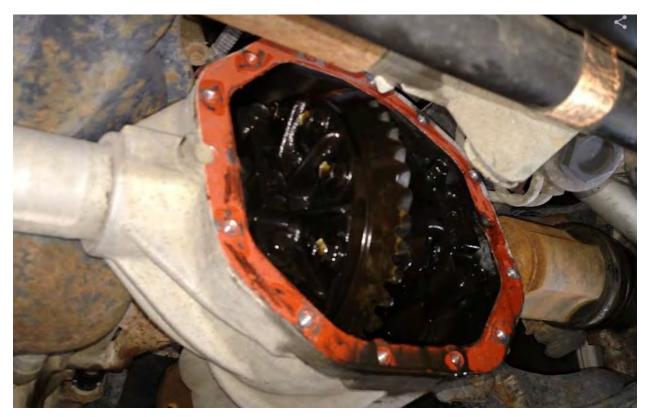
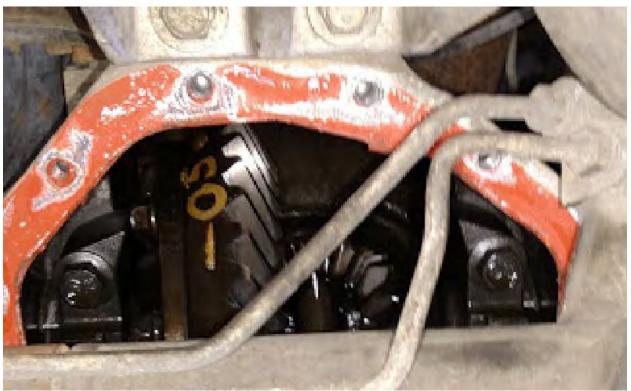
The housing/diff mating surface was thoroughly cleaned and allowed to dry (before pictures).

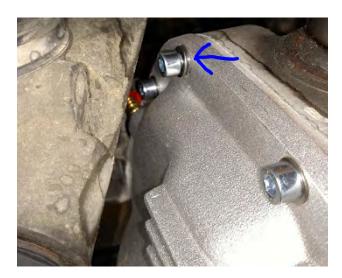
I did a dry fit and all of the bolts lined up. However, I was unable to tighten this bolt (and the one on the opposite side top, same position) with my 3/8 drive hex head driver because of the limited distance between the rack and the bolt head. A modified Allen wrench could be used to tighten this bolt.

I will be using the original bolt here and on the opposite side temporarily and will install the new bolts when I replace the steering rack this fall.

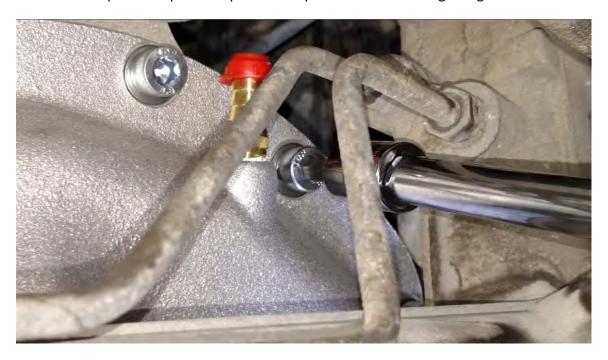
I found this bolt to be the most difficult to tighten. I used white Teflon tape to install the brass vent tube and also pushed a plastic cap over it to prevent debris from getting into the differential.

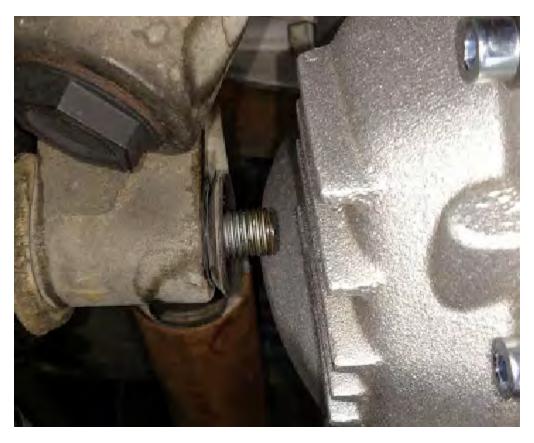
The diff cover did clear the rack bolt, but I elected to cut 1/4 inch off the rack bolt to allow maximum clearance and still leave enough thread to fully tighten the nut.

The large rack bolt did not need to shortened, but for my reassurance I cut some off to make certain it did not hit the new differential cover during hard jolts and bumps. With the steering rack bolted directly to the frame, and the differential bolted directly to the engine, I believe the only movement of the differential housing would come from the play in the motor mounts, which would be minimal.

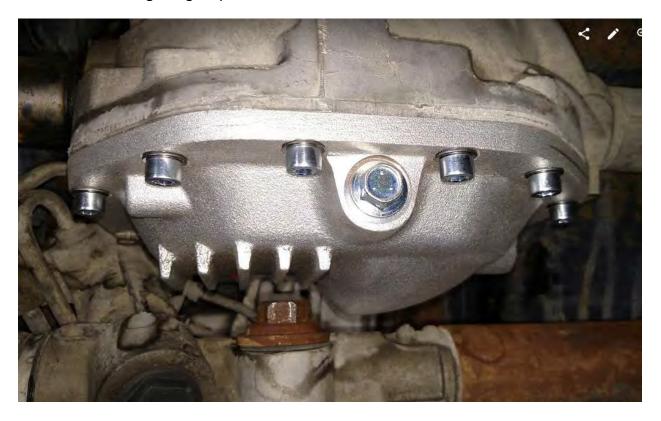
This is a view looking straight up from the floor.

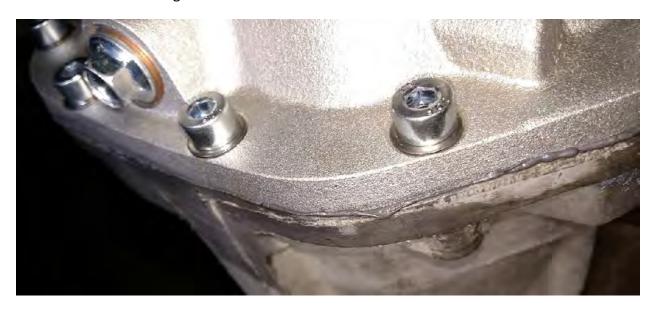
After tightening the bolts, a small amount of sealant pushed out, even after applying only a 1/8 inch thick bead to the housing.

After the dry fit, I applied 1/8 inch of black silicone to the housing in a pattern specified in the instructions provided by PML.

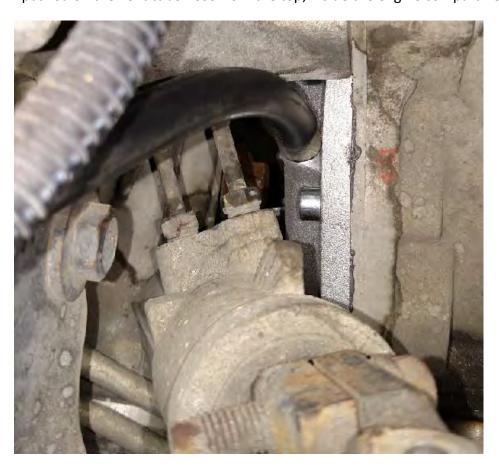
I pushed on the vent tube hose from the top, inside the engine compartment.

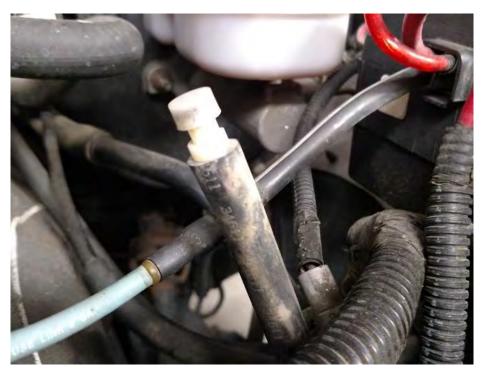
The vent hose shows no signs of blow-by or leakage after 3 weeks of use.
