PML GM 4L80E Deep 1997 And Later Transmission Pan

PML Part Number 9437

Installation Suggestion for Hummers

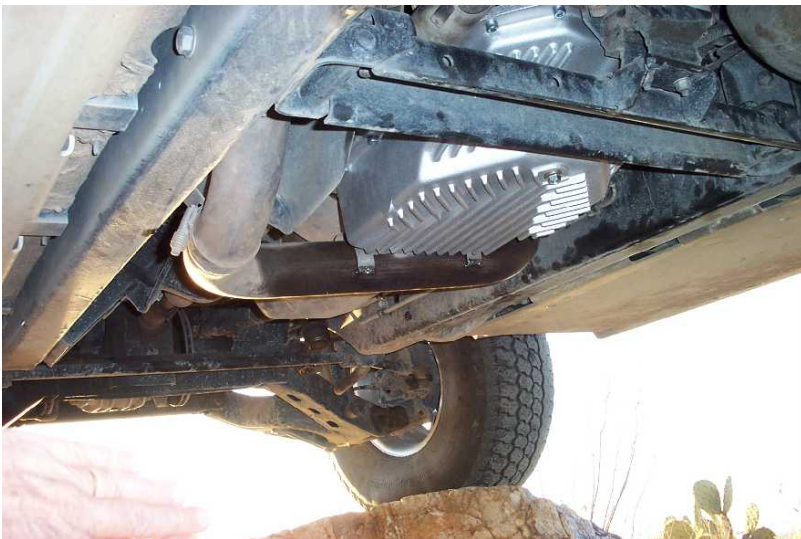
On this 1997 Hummer H1 Turbo Diesel, the PML 4L80E pan, part number 9437, holds approximately 7.5 quarts of oil compared with 5 quarts for the stock pan.

On some Hummer H1 vehicles, to install the PML transmission pan, the transmission shift linkage bracket must be modified in two ways:

1. The edge of the mounting flange part of the bracket closest to the outside wall of the transmission pan must be trimmed approximately 3/16" to gain clearance between the edge of the bracket and the outer wall of the pan. This is required because the wall thickness of the cast aluminum pan is greater than stock and reduces the distance from the side wall of the pan to the mounting holes for the linkage bracket.
2. The spacers tack welded to the mounting flange of the linkage bracket must be removed. These spacers move the bracket away from the transmission pan. The added thickness (.300" or more) of the gasket flange of the cast aluminum pan takes the place of these spacers.

Once installed, the lowest point of the cast aluminum pan will be slightly above the frame rails.
